Inspection Report

Sample Report Condo

123 Nowhere St.
Big City, MN NA

Date: 10/13/2006	Time: 8:44 AM	Report ID: Sample Report Condo 3
Property: 123 Nowhere St. Big City, MN NA	Customer: Sample Report Condo	Real Estate Professional:

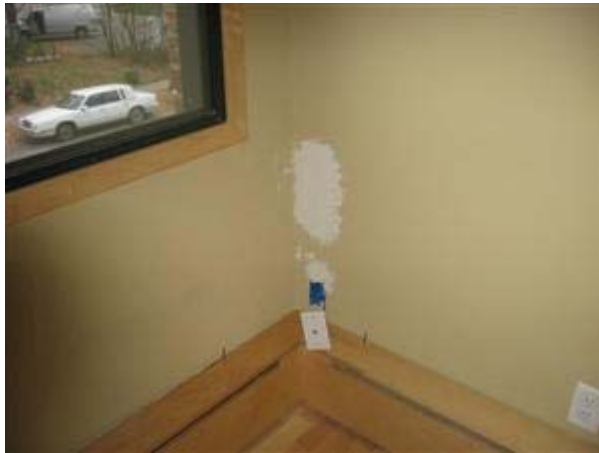
10.1 Picture 1

(COMMENT) REPAIRS MADE TO WALL(S)
