Inspection Report

Sample Report Condo

123 Nowhere St.
Big City, MN NA

Date: 10/13/2006	Time: 8:44 AM	Report ID: Sample Report Condo 3
Property: 123 Nowhere St. Big City, MN NA	Customer: Sample Report Condo	Real Estate Professional:

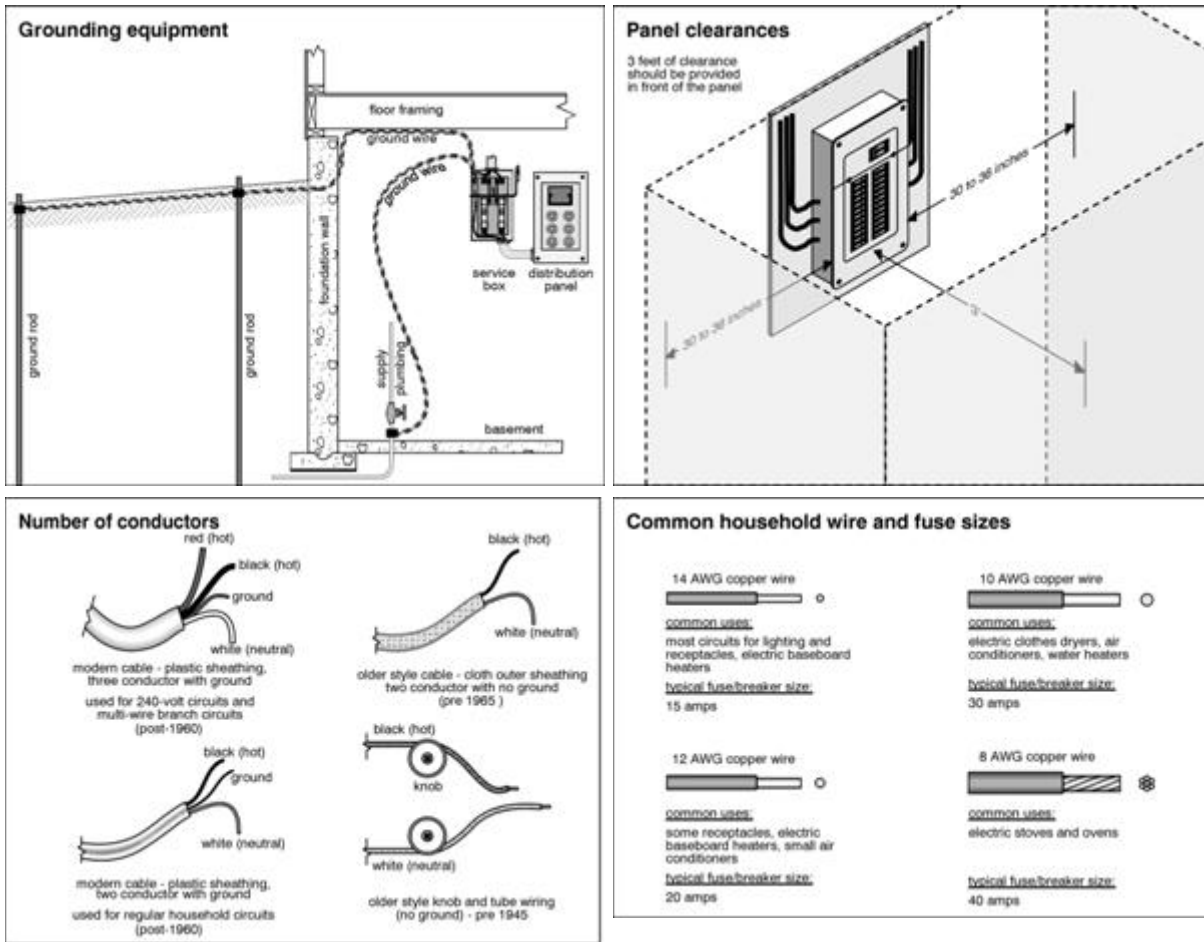
Comments: DEFECTIVE, SUMMARY

(MAJOR DEFECT) THE MAIN PANEL HAS A 100 AMP MAIN BREAKER WHICH REQUIRES A MINIMUM WIRE SIZE OF 4 FOR COPPER. THE WIRES USED IN THE MAIN PANEL ARE 6 WHICH IS TOO SMALL.
